Caha Tunnel Rock Repairs and Improvements including Non-Destructive Testing

ABSTRACT: This paper provides an overview of the recent short-term repair works by means of rock removal methods, and non-destructive testing (NDT) of Caha tunnel and thus providing an indication of suitable solutions in ensuring long-term structural validity of the tunnel.

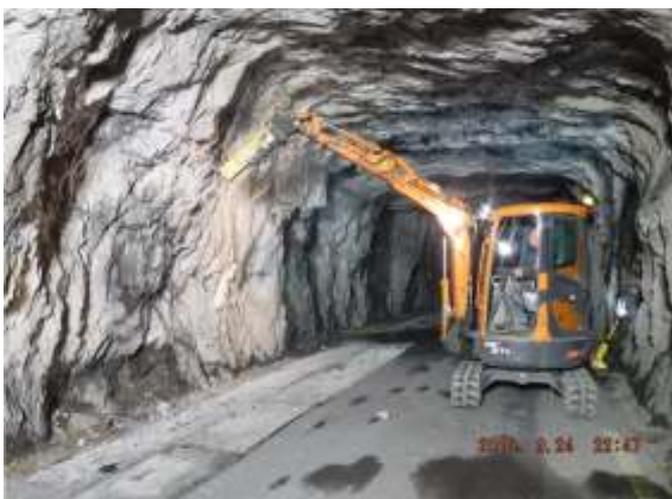
The tunnel was marked out in advance using the conclusions of both the hammer-tap survey and the geological & rock mass inspection. Any sections of loose or friable rock which could not be previously removed by hand methods were done so using mechanical rock breakers. Adequate safety measures were in place for the site operatives and protection to the existing N71 was maintained with rubber matting. Upon completing rock removal works at each section, a hammer-tap inspection was carried out by the Engineer to ensure each section presented a stable surface without evidence of loose rock.

Figure 5. Mechanical breaker removing loose rock

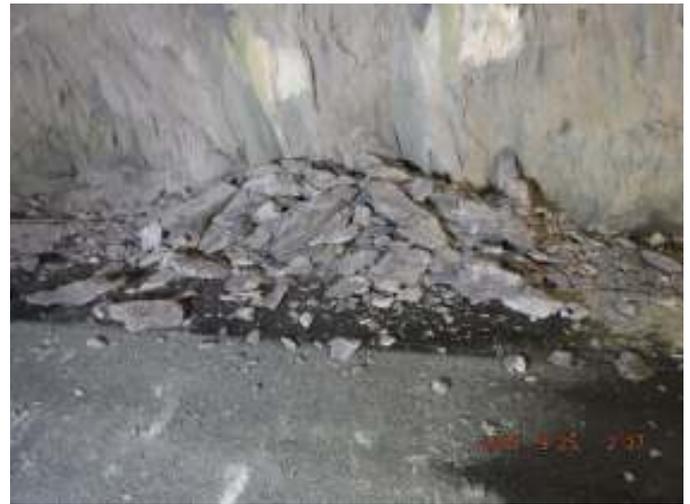
Figure 6. Loose rock removed from an identified section

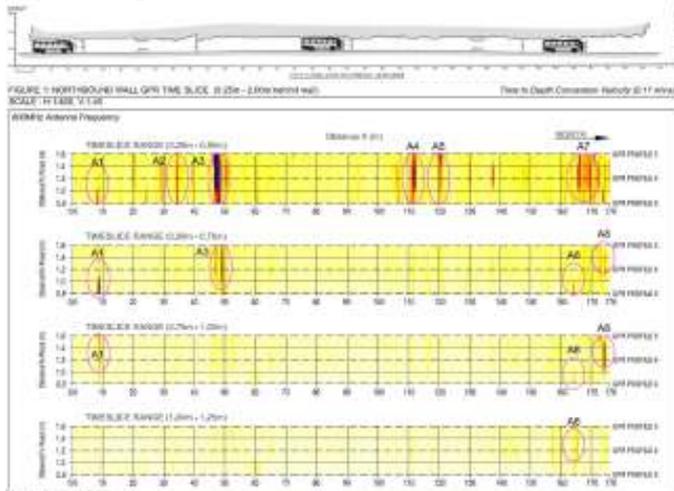
Figure 7. GPR plot of western wall of the tunnel [4]

The plots produced indicate that the features typically penetrate to a depth of 0.75m behind the walls of the tunnel but extend to greater depths within the vicinity of the north portal. These are interpreted as indicating fracture planes which could act as release surfaces. In combination with other rock mass fracturing, this may result in future localised weakening of the rock with these features typically extending to a depth of 0.75m before the rock mass becomes tight. Towards the northern portal these fracture surfaces extend to greater depth on the east wall and there are fractured features to a depth of 1.25m.
